Inspector's Daily Report

21				
IDR Sheet	1	of	1.	Sheets	Final Record Book	Page	
Contract			D	ay		Date	0
C-7852				Wednesday		June 29, 2011

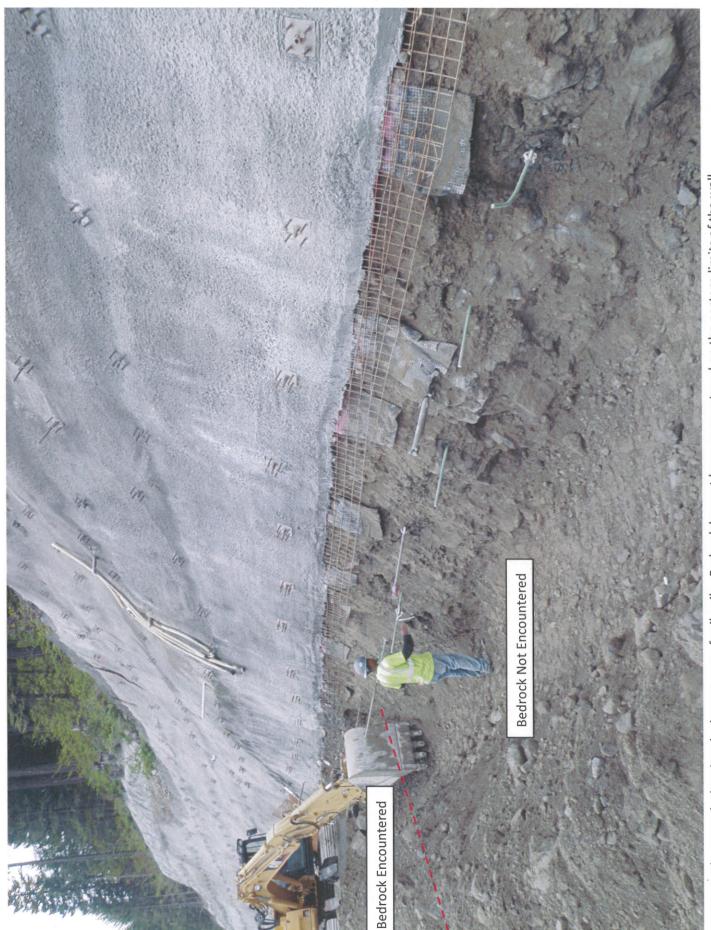
I arrived on the east side of the project and met Brad Schut. Brad indicated that he wanted to take a look at the east end of the soil nail wall. According to the plans, the contractor was expecting to encounter bedrock at the current elevation and he wanted us to take a look and verify if the current bench elevation had encountered bedrock or not. Brad and I walked up to the east end of the soil nail wall and it was clear that the contractor had not yet encountered bedrock at the eastern limits; however, it appears that bedrock was encountered approximately 50 to 60 feet west (Figure 1). Jerry Wood met us on the east end of the project and he advised that an additional row of soil nails would be installed on the eastern limits of the soil nail wall until bedrock is encountered. From the highway, it appears that bedrock should be encountered just beneath the next row of soil nails.

Figure 1. A photograph showing the lowest row of soil nails. Bedrock has not been encountered on the eastern limits of the wall.

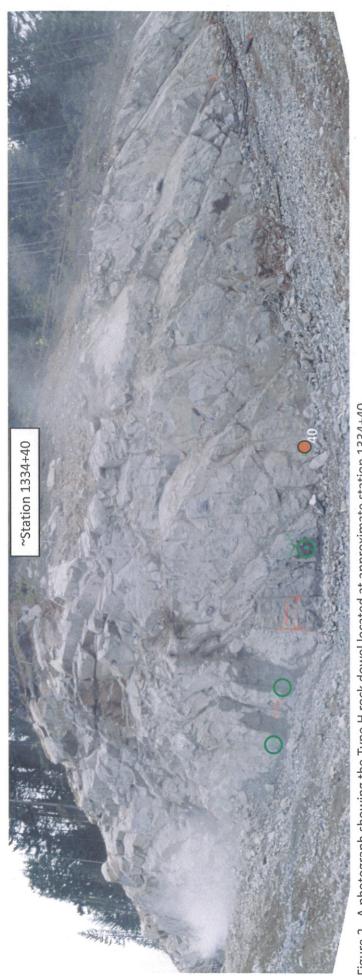
Brad and I walked up Jenkin's Knob and located one 40 foot Type H rock dowel around station 1334+40 (Figure 2). No other dowel locations were available for layout until the contractor excavates more material. Currently, NW Cascade is drilling the rock dowels that were located last week. Adam (NW Cascade) indicated that they would be finished drilling and grouting these rock dowels by the end of the shift tomorrow.

Figure 2. A photograph showing the Type H rock dowel located at approximate station 1334+40.
